Chapter 5: Find Solutions - Exploring BMP Options

5.1 Introduction

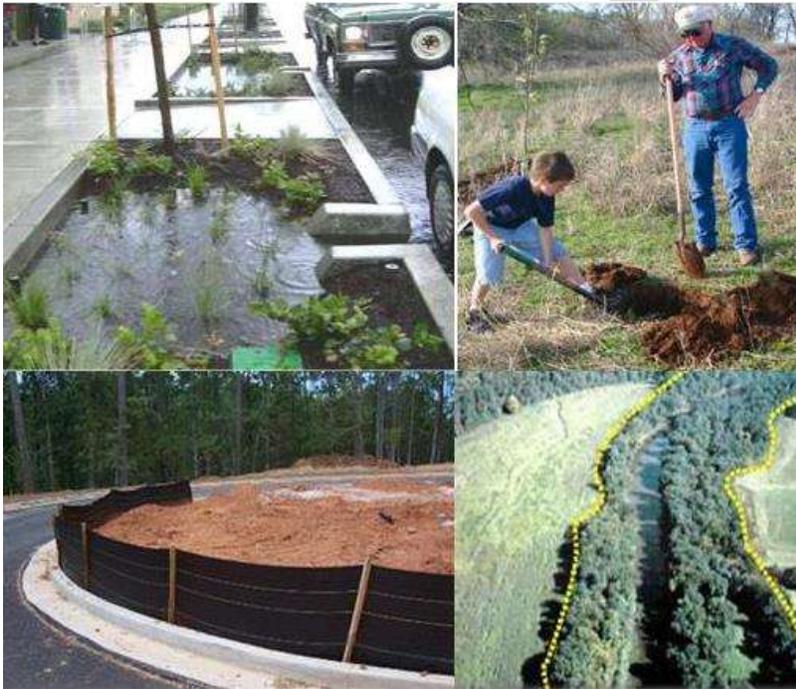
Figure 5.1: Examples of structural best management practices.

BMPs can greatly improve water quality. Curb cuts in roads (top left) capture stormwater to decrease runoff pollution. Trees help prevent erosion and reduce instream water temperatures (top right). Riparian (vegetative) buffers near waterways (bottom right) improve habitat and catch pollutants before they enter the water. Silt fences (bottom left) reduce erosion and keep sediment out of waterways.
